Contract #: 04-0120F4Cty: SF/ALA Rte: 80 PM: 13.2/13.9File #: 69.28**WELDING INSPECTION REPORT****Resident Engineer:** Pursell, Gary**Address:** 333 Burma Road**City:** Oakland, CA 94607**Report No:** WIR-002910**Date Inspected:** 12-Jun-2008**Project Name:** SAS Superstructure**OSM Arrival Time:** 630**Prime Contractor:** American Bridge/Fluor Enterprises, a JV**OSM Departure Time:** 1530**Contractor:** Zhenhua Port Machinery Company, Ltd (ZPMC), Changxing Island **Location:** Shanghai, China

WELDING INSPECTION REPORT

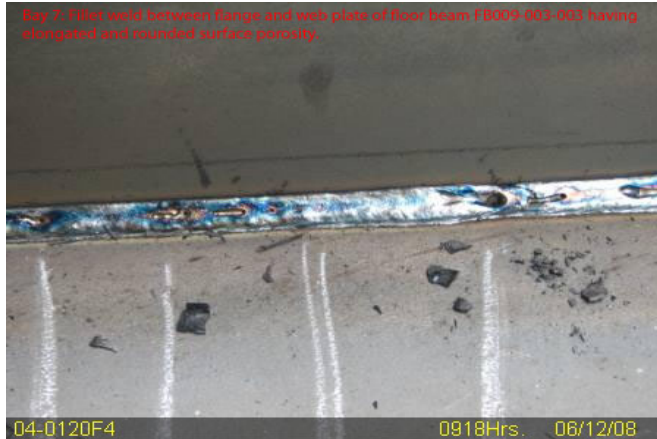
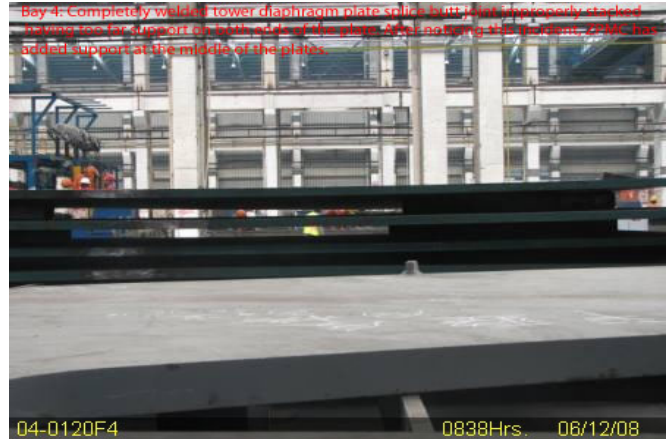
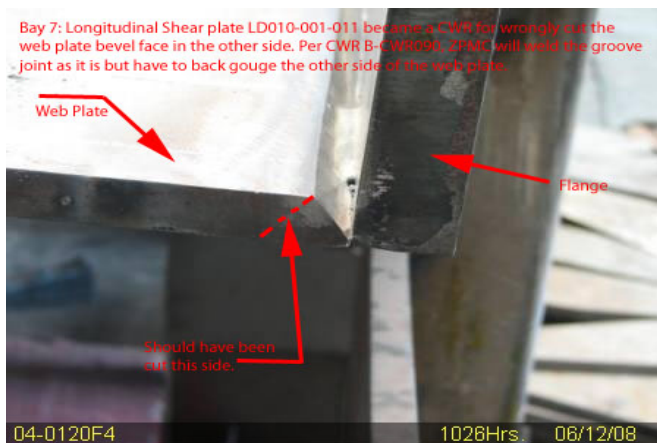
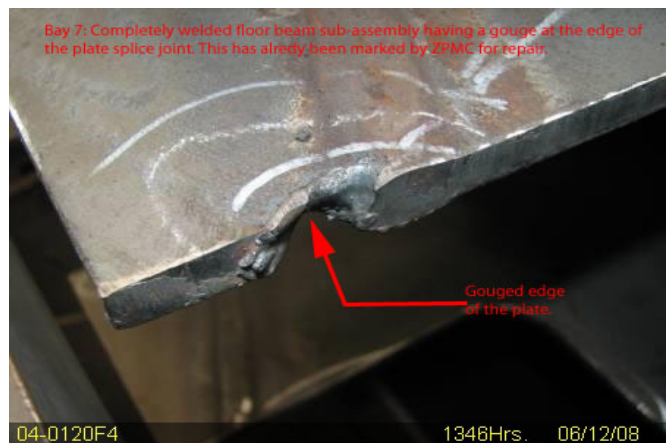
This QA observed completely welded plate splice for various tower diaphragms were stacked on top of each other but having support at each end of the plate too far which make the plates sagged at the middle. Caltrans QA informed one of the ABF QA Inspector concerning this and he told this QA that he would ask ZPMC to put more lumber at the middle of the plates. See photo below.

QA Inspector JLizardo randomly observed ZPMC qualified welder ID #044824 FCAW PJP welding longitudinal shear plate LD010-001-011. The welder was observed welding in the 2G (horizontal) position utilizing a Flux corded arc welding (FCAW) process with a 1.4mm diameter electrode, filler metal brand E71T-1, class Supercored 71H, semi automatic. This shear web plate was beveled on the wrong side so ZPMC has to correct this by welding as it is but need to back gouge the other side of the web plate per written critical weld repair B-CWR090. QA Inspector Lizardo observed the ZPMC QC CWI Inspector Huang Wei Qing verifying that the welding parameters and pre-heat were in accordance with the Welding Procedure Specification (WPS). QA Inspector observed preheat and welding parameters measured by the QC CWI Inspector were deemed acceptable. See photo below.
